2017 F450-550 Front Gatorback CR Mudflap Kit Installation Instructions GCR41F

### 766164/766/766316/766319/ 766325/766328/766331

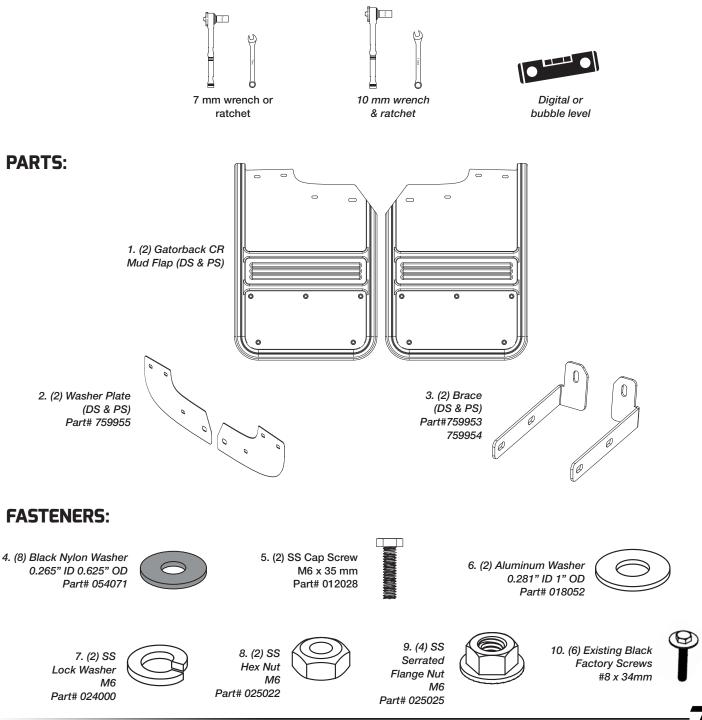
# **5. TIGHTEN ALL FASTENERS** 6. REPEAT PROCEDURE ON PASSENGER SIDE (PS) 3 **DIAGRAM (DRIVER SIDE)** A 2 10 TRUCK REAR 1 -TRUCK FRONT

a. Loosely install Gatorback CR Mud Flap (#1) using Washer Plate (#2) using 3x Factory Screws (#10) and 3x Nylon Washers (#4).

b. Loosely install Brace (#3) using 2x M6 Serrated Flange Nuts (#9). Threads may need to be cleaned of any paint residue.

c. Loosely attach Brace (#3) to Mud Flap (#1) using 1x 1/4" Cap Screw (#5), 1x Nylon Washer (#4), 1x Aluminum Washer (#6),
